Northern Ireland Snow/Ice Storm

30/31 March 2010

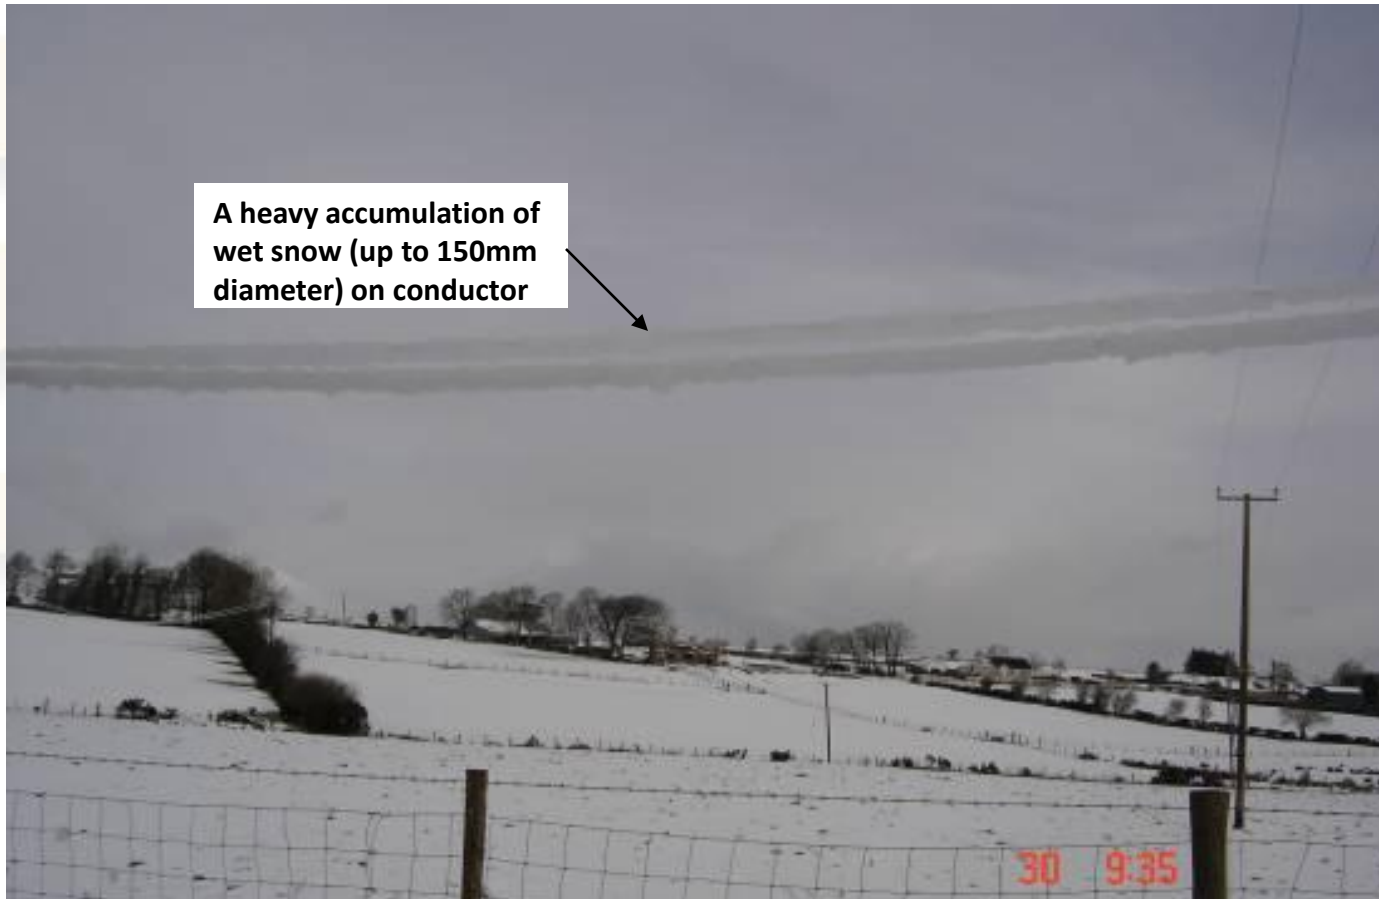
Snow Accretion

A heavy accumulation of wet snow (up to 150mm diameter) accreted around the conductors and on some spans which did not fail, the conductors were weighted down to within 300mm of the ground. The accumulation of wet snow was worst on conductors running east-west, which were perpendicular to the prevailing wind.
