Northern Ireland Snow/Ice Storm

30/31 March 2010

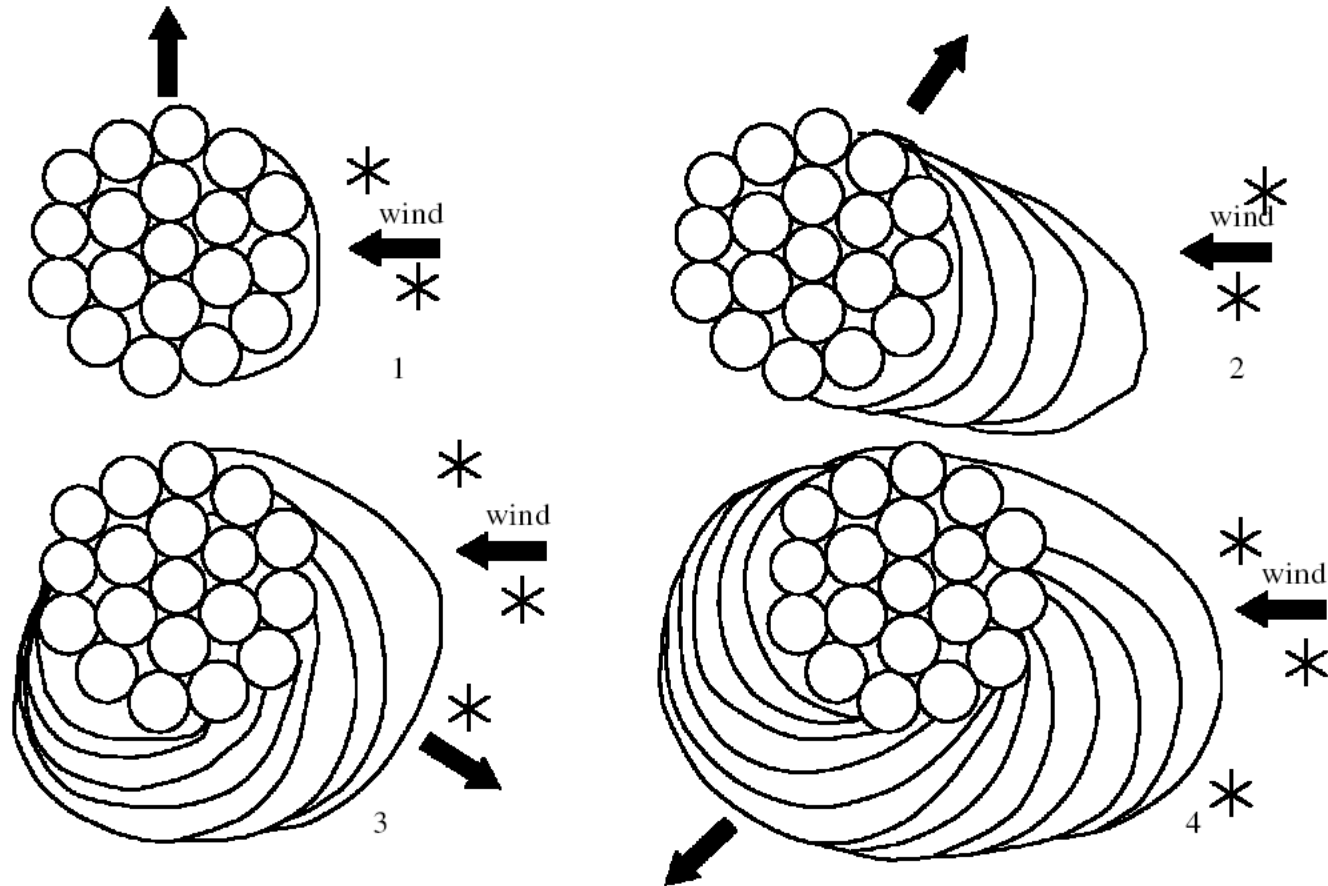
Snow Accretion

A heavy accumulation of wet snow (up to 150mm diameter) accreted around the conductors and on some spans which did not fail, the conductors were weighted down to within 300mm of the ground. The accumulation of wet snow was worst on conductors running east-west, which were perpendicular to the prevailing wind.

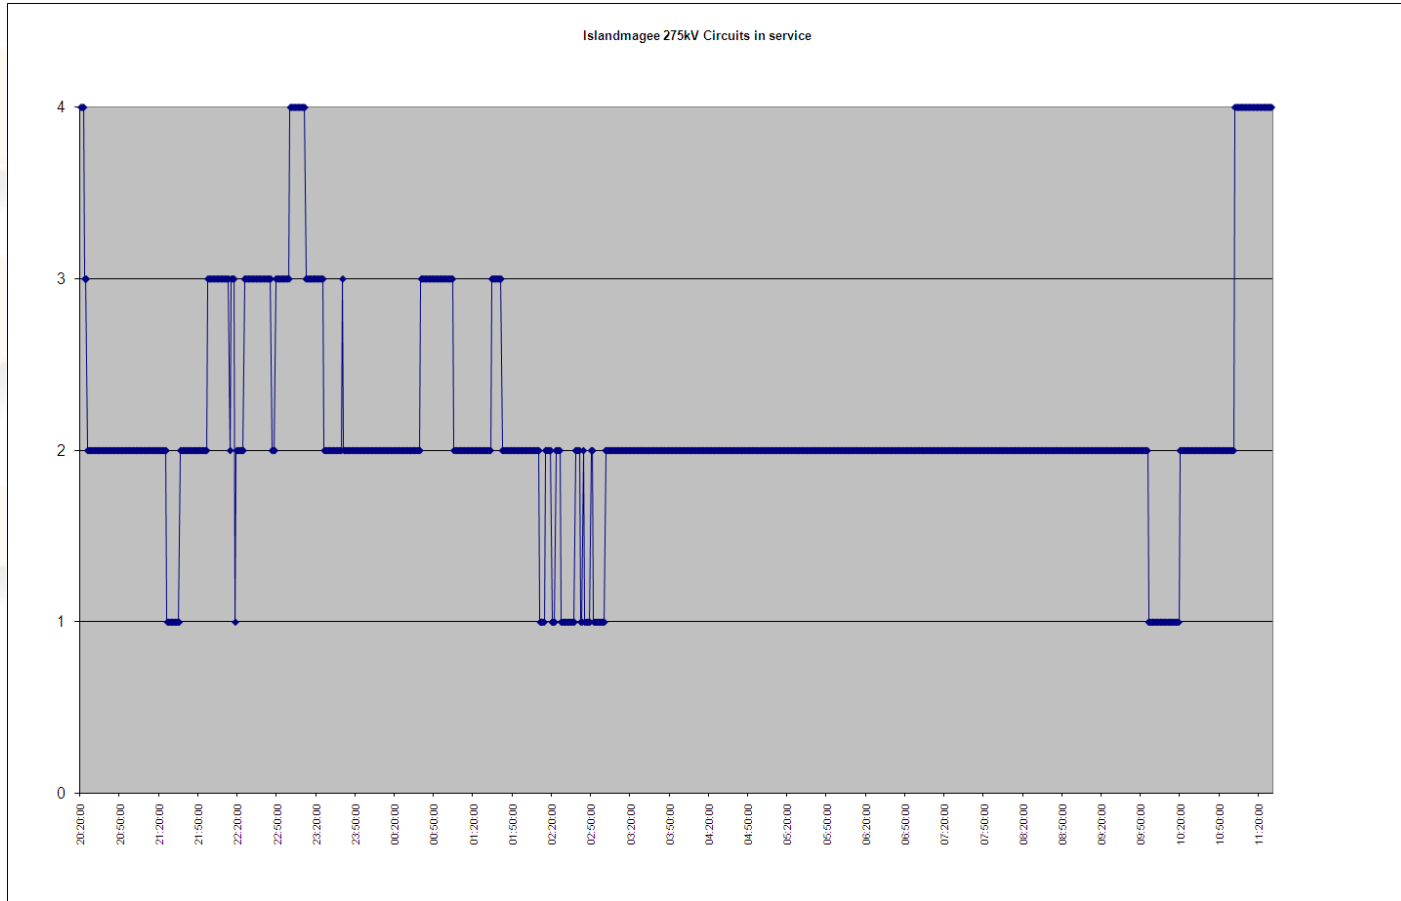
275kV Ccts ex BPS/Moyle

- 275kV tower lines – double circuit L2 and L8 design with duplex “zebra” conductor
- Excessive sagging due to wet snow accumulating on middle phase – new phenoma on system
- Previous history of galloping due to ice accretion – de-spacing and dog-legging of conductor
